## Newton Green Golf Course Pond Management Recommendations

At the request of Mike Oliver, President of the Newton Green Golf Club, Leonie Washington (Wildlife Site Adviser) of Suffolk Wildlife Trust visited 5 fluctuating ponds on 5<sup>th</sup> & 11<sup>th</sup> November 2015, situated within the County Wildlife Site with a view to offering management advice for each.

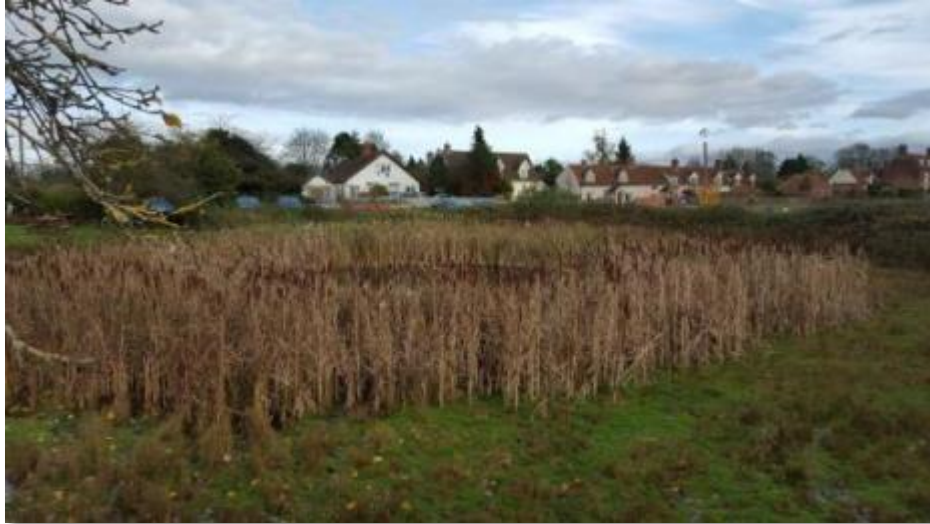
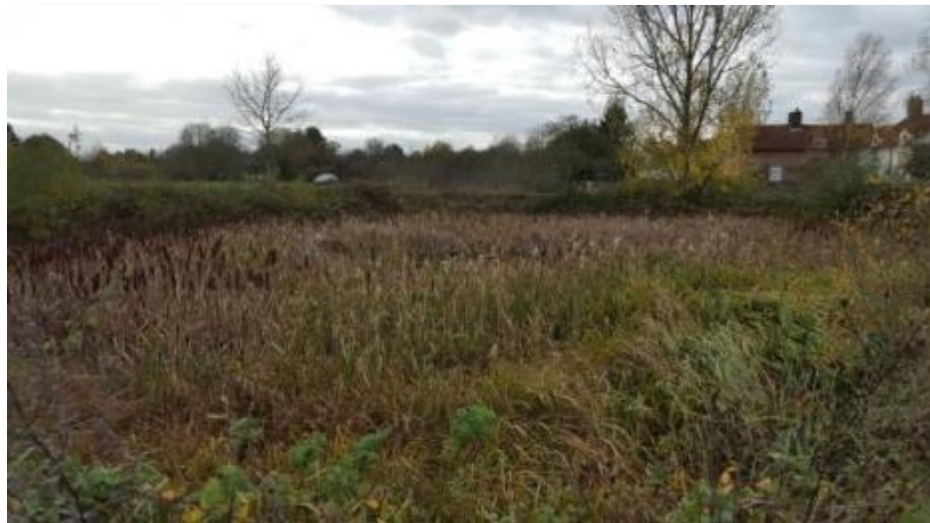
### Saracens Head Pond– TL 91566 40770

This village pond is an ancient livestock-drinking pond situated next to the Saracens Head public house, A134 and village green. It collects run off from the adjacent road and fluctuates seasonally.

The bank is dominated by bramble, willow and nettle and smooth newts were observed sheltering under leaf litter. The margins with tussocks of false-fox sedge, jointed rush, soft rush, reed canary grass and invading reed mace. New Zealand pygmy

weed dominates the drawdown zone and shallows and dense stands of reed mace are concentrated around the remaining open water.

Since the last assessment in 2009 the pond appears to be holding less water as invading species such as reed mace and reed canary grass have continued to encroach unchecked.

To restore the pond to a better condition for wildlife and allay peoples concerns, I would recommend some accumulated organic matter (leaf litter) and reed mace removal, removing fish if still present, willow coppicing, treatment of New Zealand pygmy weed and signage.

digger machine, 'push in' two thirds of the perimeter bank (as far back as acceptable by Village Green Trust as this clearly takes out some of the mown grass area) and 'pull out/deepen' the central pond (taking care to avoid any clay seal) to create a more gentle gradient. This should not be an immaculate gentle gradient but include some variation in bank topography both terrestrially and that part which will be seasonally underwater.

- At the same time as doing the re-grading work with a digger, remove some invading reed mace – it will soon grow back but this will ensure there is still plenty of open water. Removing accumulated organic matter and reed mace at intervals is necessary to reduce nutrient build up and encroachment. The removed vegetation can be spread on the seasonal shelf where it will subsequently be covered with pond/bank spoil and may temporarily suppress the New Zealand pygmy weed. Consider creating an underwater cliff/drop off to reduce the spread of reed mace across the water body but be sure to add deep-water signs for the public.
- The removed leaf litter could be spread thinly on low-lying ground away from the ponds to prevent it from reentering the pond.

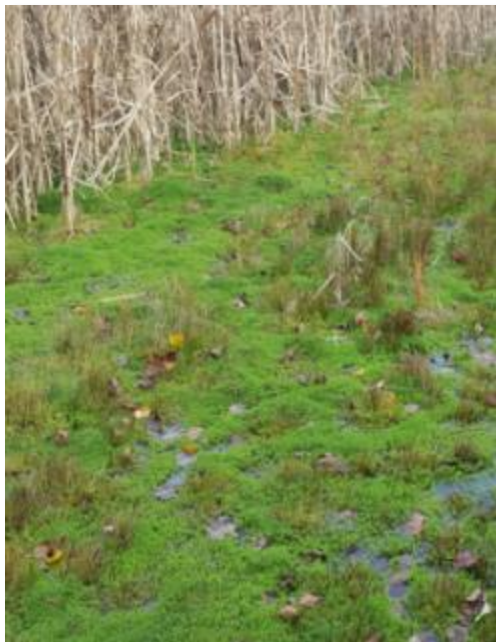
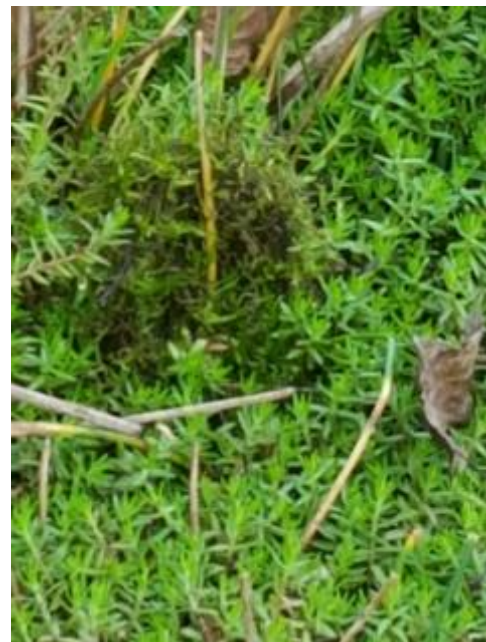
New Zealand Pygmy Weed has unfortunately become well established in the shallow boggy areas. The plant is particularly invasive and non-native. It has formed a dense mat/carpet and will eventually outcompete other vegetation and reduce the ponds benefit to invertebrates and amphibians. Due to its invasive nature, pond hygiene is particularly important to avoid spreading the plant to other ponds; therefore care should be taken not to transport the plant on footwear and tools used to manage the pond. The species can be controlled chemically or mechanically but is impossible to eradicate entirely. (Please see attached information sheet for additional management instructions)

Additionally self-set willow are establishing around the pond margins and within the shelf area. If left, they will grow rapidly and further dry out the pond. They will also deposit large amounts of leaf litter into the water body therefore increasing pond sediments and organic matter and accelerating the likelihood of regular pond clearance.

- Next summer when water levels are low, treat the dry part of the plant only, with a formulation of glyphosate approved for use in aquatic situations. This will need to be applied by a trained and qualified herbicide sprayer and may need to be repeated each year to keep on top of the spread. (See attached factsheet for further information)

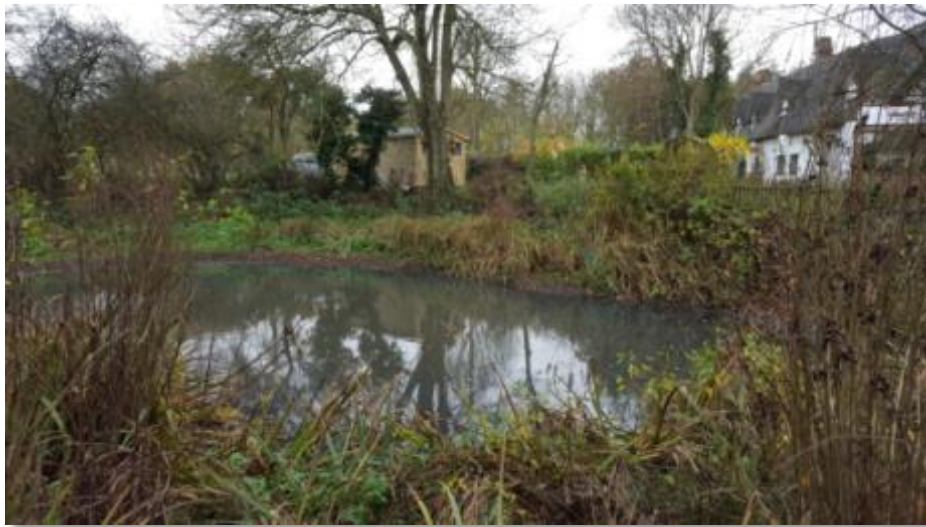
### **Potash Pond – TL 91459 40610**

The pond is holding water well with emergent and bankside vegetation and a vegetated and muddy drawdown zone.

Few submerged plant species occur within the water body and large amounts of leaf litter have accumulated. In previous years the pond may have received run off from a septic tank. This combined with the leaf litter has created a black greasy looking sediment and oily sheen.

The main issue with this pond is the accumulation of organic matter (leaf litter), the potential encroachment of developing scrub and dense stands of iris on the northeast edges and shading from mature hawthorn scrub on the southern boundary.

To improve the pond I would recommend some removal of accumulated organic matter and the coppicing of scrub along the southern edge to allow light to reach the pond and reduce leaf litter.

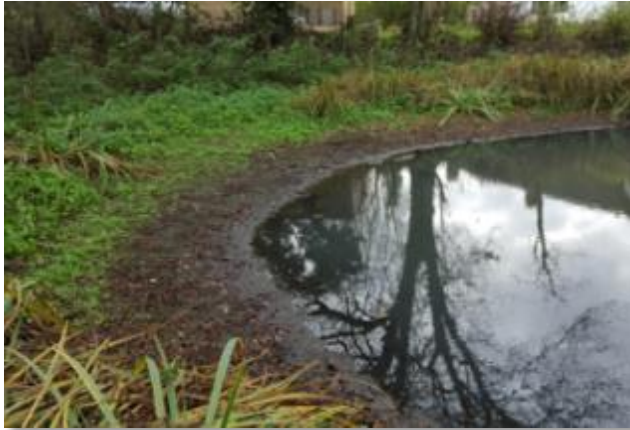
Gently shelving and shallow water around a pond edge is also the most affected by seasonal water levels and is known as the 'drawdown zone'.

A common misconception about ponds is that water levels should remain stable throughout the year. Occasional drying out and re-hydrating of the pond bed in the drawdown zone is vital to the survival of many flora and fauna.

The drawdown zone can be one of the most important features of a pond as these areas provide a rich habitat for many plants, invertebrates, amphibians, birds and small mammals therefore care should be taken not to impact the drawdown zone.

- In the autumn, from the path adjacent to the eastern edge of the pond using a digger machine, gently remove the accumulated leaf litter from the main water body only, taking care not to damage the pond substrate or remove any soils and gravels.
- The removal of organic matter may improve the general appearance of the water and encourage submerged vegetation to establish. Removed spoil should be left on the bank side for a while to allow any creatures to escape back to the pond before being removed and thinly spread in surrounding low lying areas of scrub where it will not easily be washed back into the pond.

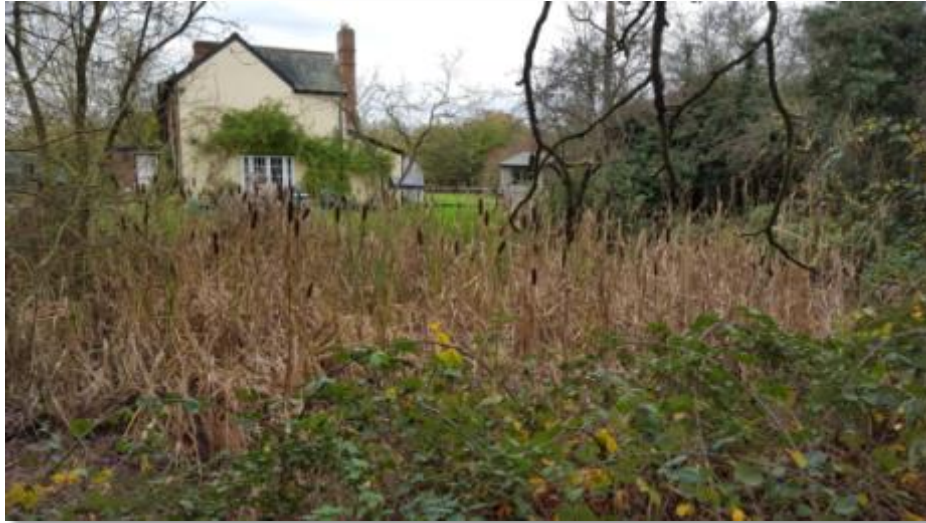
## **Butchers Pond – TL 91506 40459**

Situated next to 1 Butchers Cottage the pond is holding very little water, is dominated by a dense stand of reed mace and shaded by dense hawthorn scrub on three sides with a steep grassy bank from the garden edge.

The pond is heavily shaded from surrounding scrub which without management will eventually revert to closed canopy woodland, large amounts of leaf litter have accumulated within the pond basin and reed mace has encroached the entire water body leaving very little standing water. Without management this pond will quickly dry out and revert to scrub over time or become invasive.

To restore the pond I would recommend rotationally coppicing the surrounding scrub to reduce shading and annual leaf litter and removal of the reed mace stand and accumulated leaf litter

- In the autumn, from the thinner area of scrub/woodland north (rear) of the pond using a digger machine, remove all of the reed mace and associated accumulated leaf litter from within the pond basin taking care not to damage the pond substrate or remove any soils and gravels and allow the pond to re-fill naturally. Removing accumulated organic matter and reed mace at intervals is necessary to reduce nutrient build up and encroachment.
- At the same time, the southern lawned pond edge could be re profiled to create a gentler slope and planting shelf.
- Removed spoil should be left on the bank side for a while to allow any creatures to escape back to the pond before being removed and thinly spread in surrounding low lying areas of scrub where it will not easily be washed back into the pond.

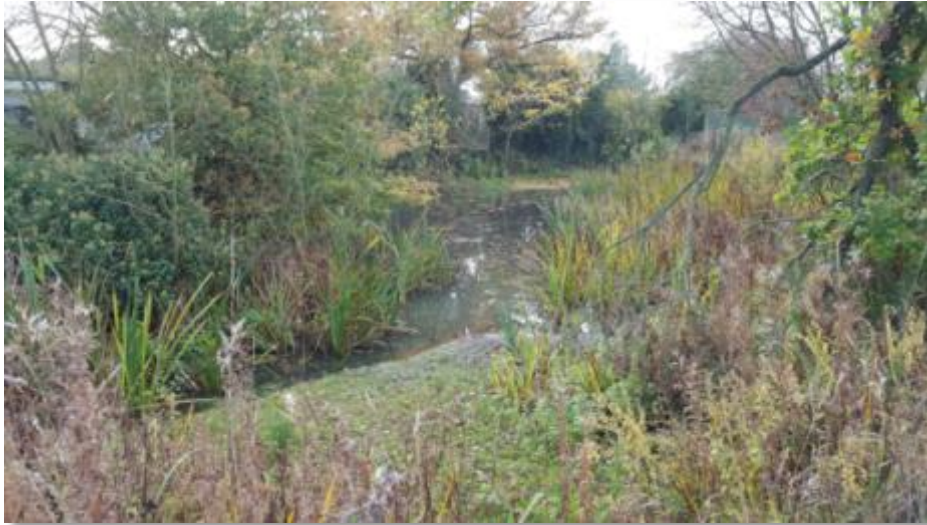
## **Plough Cottage Pond – TL 91802 40288**

This linear pond is adjacent to Plough Cottage and linked to a network of ditches. A delightful pond with emergent vegetation such as water madder, water forget-me-not, water-dropwort, water-starwort, compact rush, and iris buffered by a verge of ladies bedstraw, sorrel, willow herb, cocks foot, broad leaved dock, bramble, common knapweed and spear thistle to its north and west. Occasional mature specimens of oak, ash and willow occur around the bank margins with some self-set occurring around the pond edge.

A gravelly long slope (old livestock access ramp?) occurs at the northern edge of the pond and is partially vegetated leading to a muddy drawdown zone.

At present the pond does not present any issues and does not require management only monitoring.

Future management works could include bankside willow coppicing and oak and ash self-set pulling to reduce annual leaf litter accumulation.

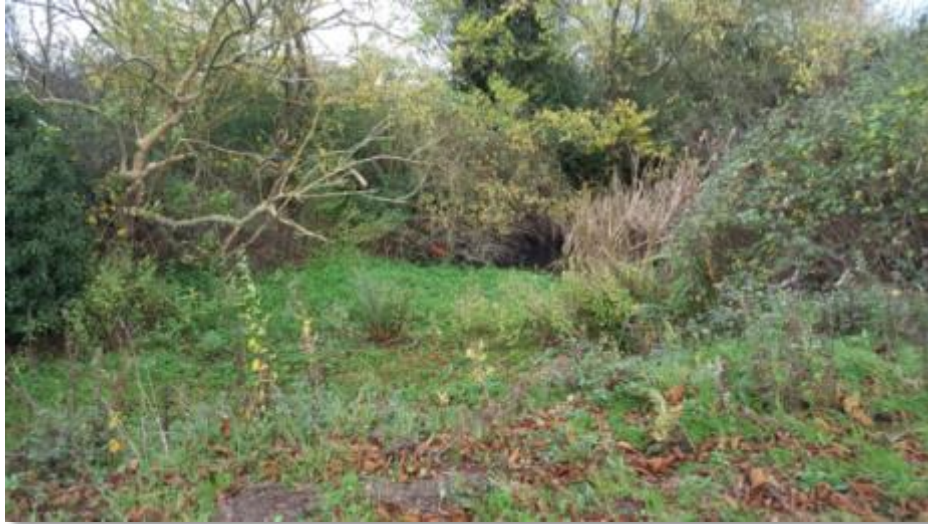
### **Playing Field Pond – TL 91846 40416**

This pond is situated adjacent to the playing field and linked to a network of ditches from its western edge. The pond basin is open and accessible from the west via a gentle vegetated gravel slope leading to silty shallows and then open water. At the time of visiting only the south east corner of the pond contained standing water with a dominant stand of reed mace in its centre.

The main issues with this pond are the dense stand of reed mace, shading by scrub and accumulated organic matter in the form of leaf litter from the annual leaf fall.

As previously mentioned the drawdown zone can be one of the most important features of a pond and so I suggest that the vegetated slope and shallows be left untouched but recommend that the reed mace and leaf litter be removed from within the main water body and that the south and eastern scrub be managed to reduce shading.
